**Κατασκευάζοντας σε ρήγματα:  
Η περίπτωση της γέφυρας Ρίου-Αντιρρίου  
«Χαρίλαος Τρικούπης»**

**Building near fault; the case study of Rion-  
Antirion Bridge “Charilaos Trikoupis”**

**Άρης Σταθόπουλος-Βλάμης, CTO, GEFYRA S.A.**

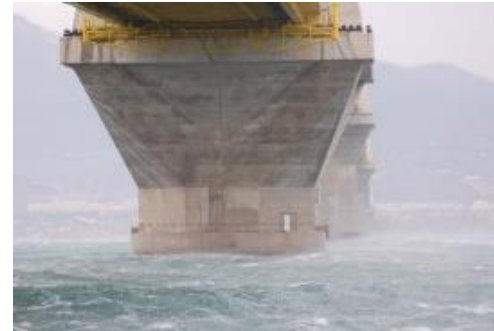
## Environmental Conditions

No bedrock encountered in first 100 m during soil investigations, while geological studies indicated similar conditions for up to 500 m.

Uniform sea bed at depth of 60 m with steep slopes near coast.

Active normal faults on both sides of Corinthian gulf, at the vicinity of Bridge while the tectonic kinematic of area indicates separation of Peloponnese from mainland Greece with rate of ~15-20 mm/year.

Due to morphology of surrounding mountains, Rion-Antirion strait is prone to the frequent & strong winds with the most frequent winds to have direction perpendicular to Bridge axis.

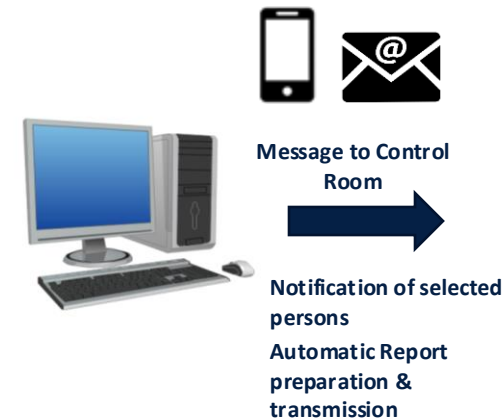
### Automated Event Management (Smart Monitoring)

1. Automated ***detection*** of earthquake events
2. ***Classification*** of structural response
3. Proposed ***decision on traffic management*** (Real time)
4. ***Automated report*** preparation and transmission

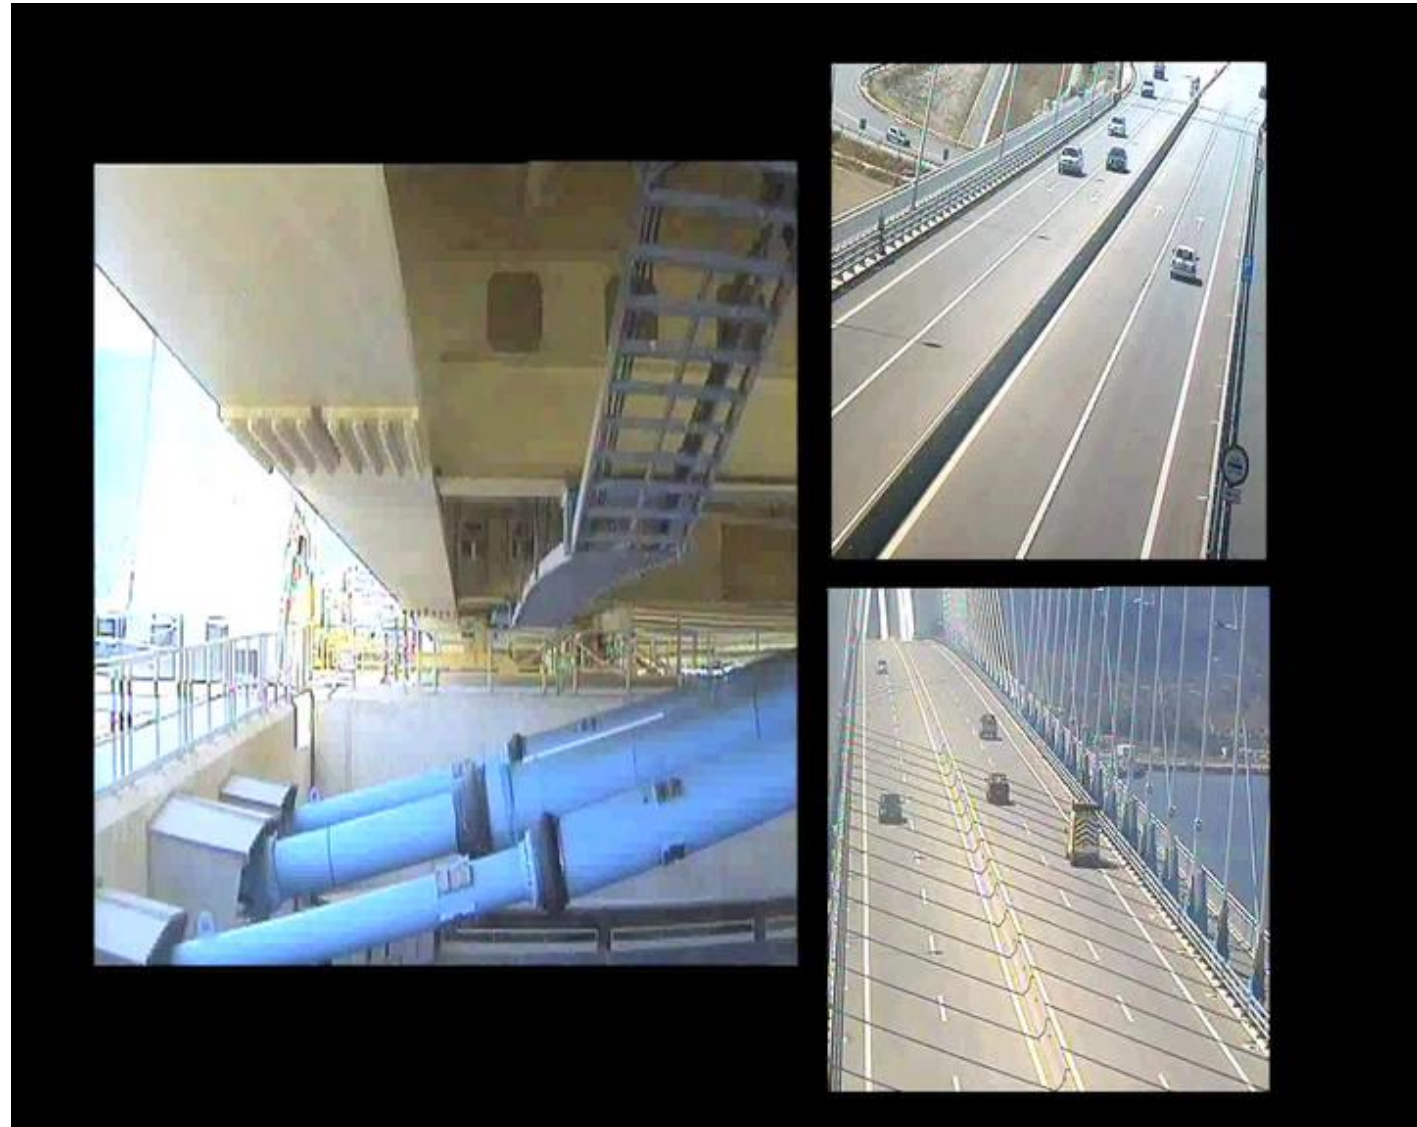
- Magnitude  $M_w=6,4$
- 36km from Rion-Antirion site.
- Focal depth: 31km
- Max PGA recorded from on-shore accelerometers: 0.127g (at Rion bank)
